Quinquennial Inspection Report

St. John's Church

Llangwm Isaf

13th December 2017

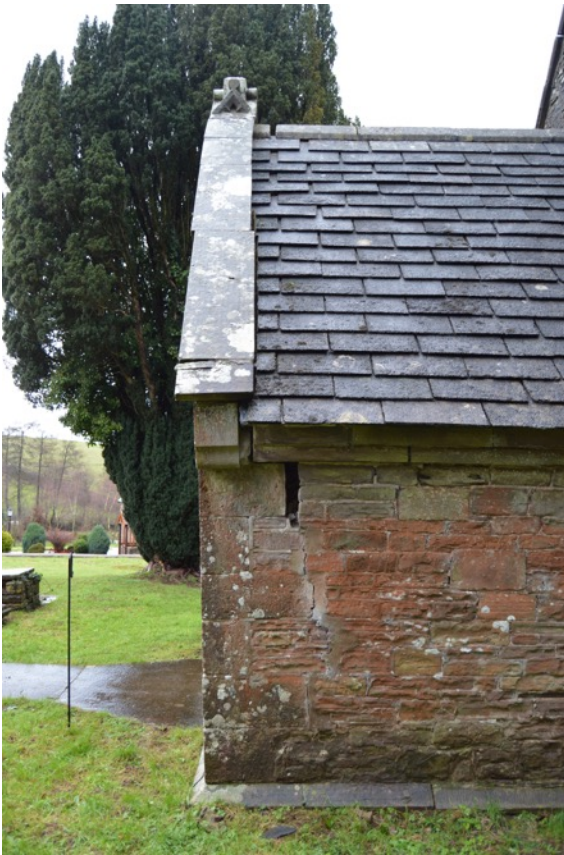
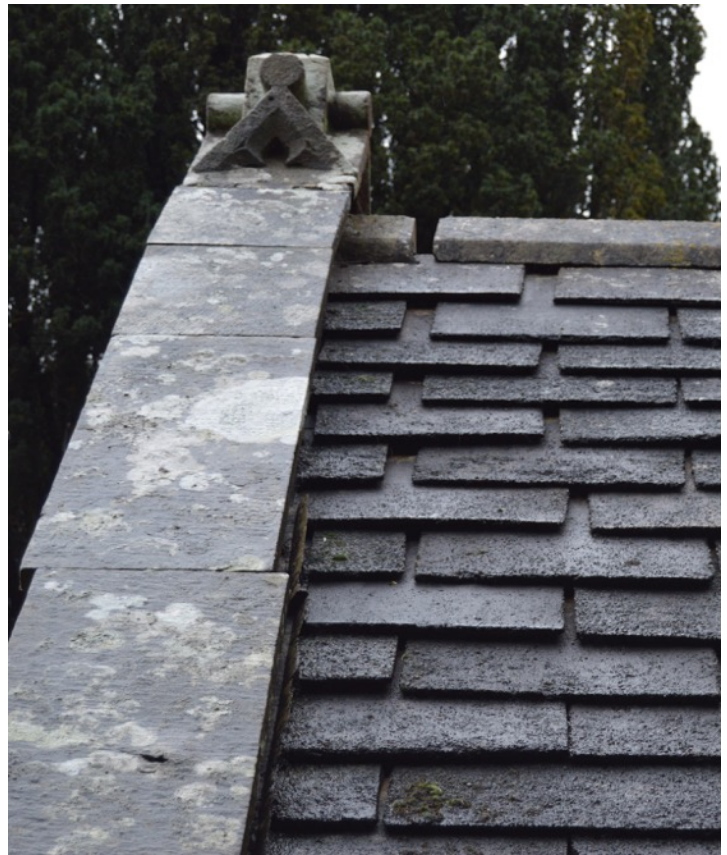
The west porch gable appears to be leaning out. There are vertical cracks at the masonry corners one of which has opened up by 50mm with the remainder being filled with cement. This in turn has opened up the vertical joints in the roof tiles, and the coping stones are also misaligned. the joints in the Porch trusses have also opened up as a result of the structural movement.

(5.) View of the Porch with signs of major structural movement evident. Note the gable is leaning over, and large crack at corner.

This has the potential to be very DANGEROUS and is likely to progress to the eventual collapse of the gable. I WOULD RECOMMEND THAT THIS AREA SHOULD BE CLOSED OFF UNTIL AND EMERGENCY PROPPING CAN BE PUT IN PLACE. For a more permanent repair it will need to be tied back to the main structure, using Cintec

ties or similar. This should be inspected by a structural engineer and a detailed specification prepared for this type of repair.

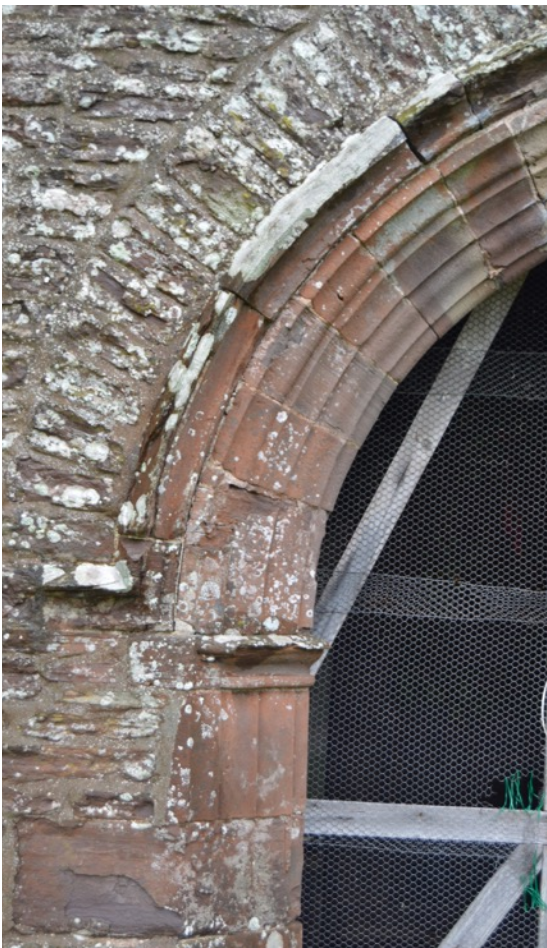
The stone arched doorway is reasonably true but many of the joints are open, probably due to the structural movement.

(6.) Stone arched doorway showing open joints likely to be caused by structural movement.

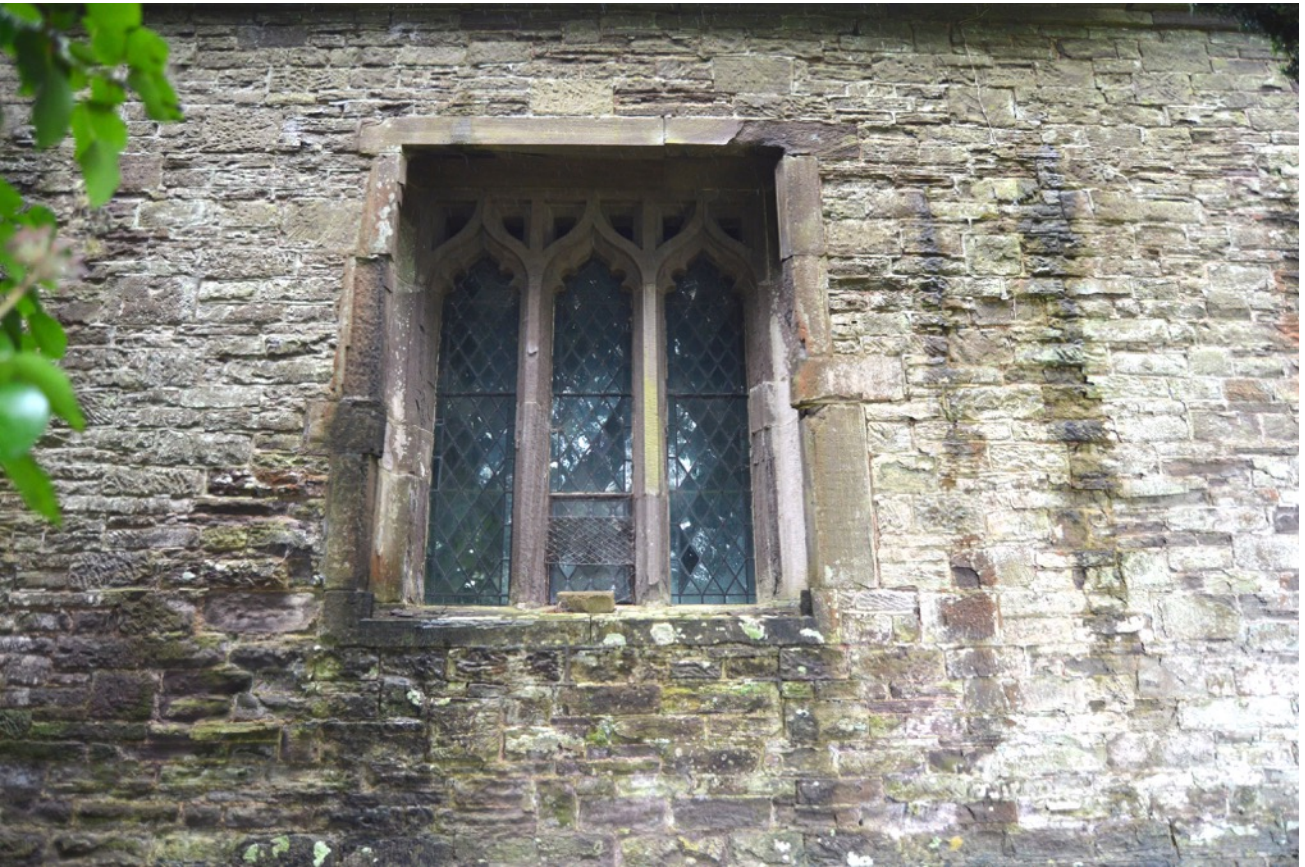
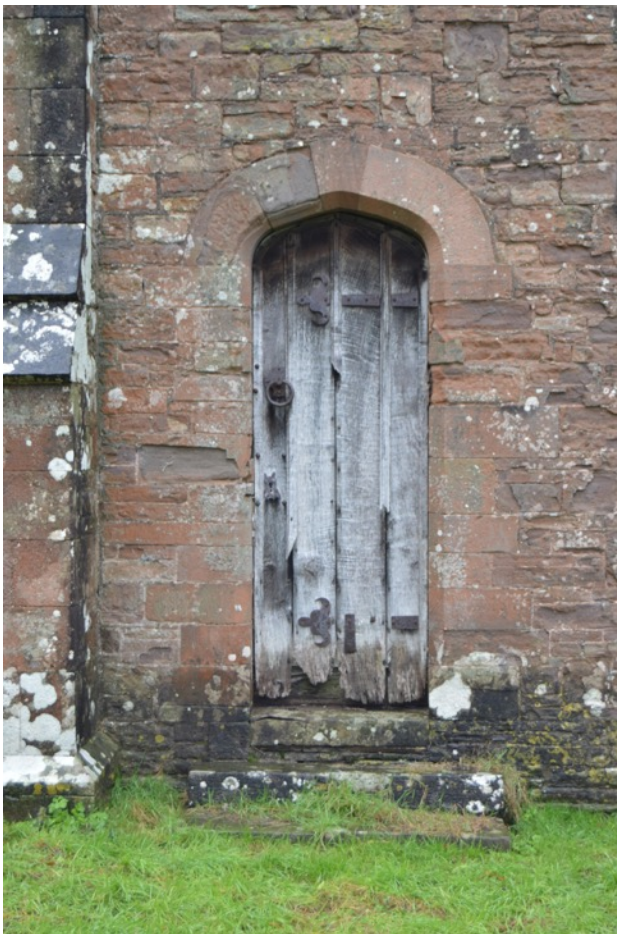
- 8.1. The building was inspected during a very wet period. There is no gutter system at the eaves. The water runs directly off the roof and onto the ground and sometimes down the walls, particularly on the north side where the lower walls batter out. consequently, the ground is very wet and it has created a very damp environment at low level.

(7.) Water ingress evidence on the exterior walls of the church. Lack of gutter system leading to rainwater running directly off roof down the walls. Also, stone window decay, with cement render over right side of frame.

(8.) The four plank wooden door has become rotten and iron strapping considerably corroded. Steps are mossy, damp and slippery.

- 8.2. The north side is also lined with thick evergreens planted in a line close to the building and coupled with the water runoff from the roof soaking the base of the walls and creating a damp environment that is/will lead to dampness inside the building. The soft purple sandstone window dressings are decaying badly on the north side of the church.
- 8.3. It is therefore suggested that a system is put in place that will remove the water away from the building as quickly as possible, such as adding metal gutters and down pipes, to gulleys and soakaways. It is also recommended that the evergreen trees be removed.

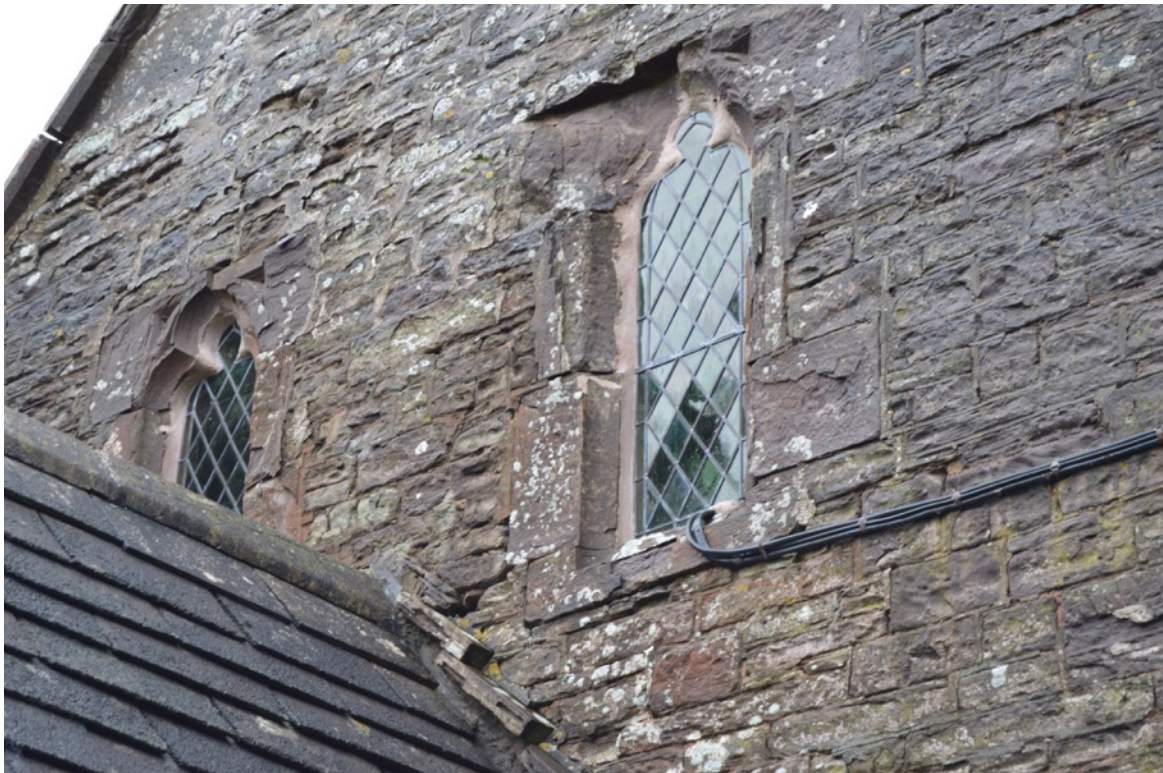
(9.) High level Nave windows with delaminating dressed stone. new glass in window and mortared in place with 'pink' mortar. Mains cable routed between glass and stone cill.

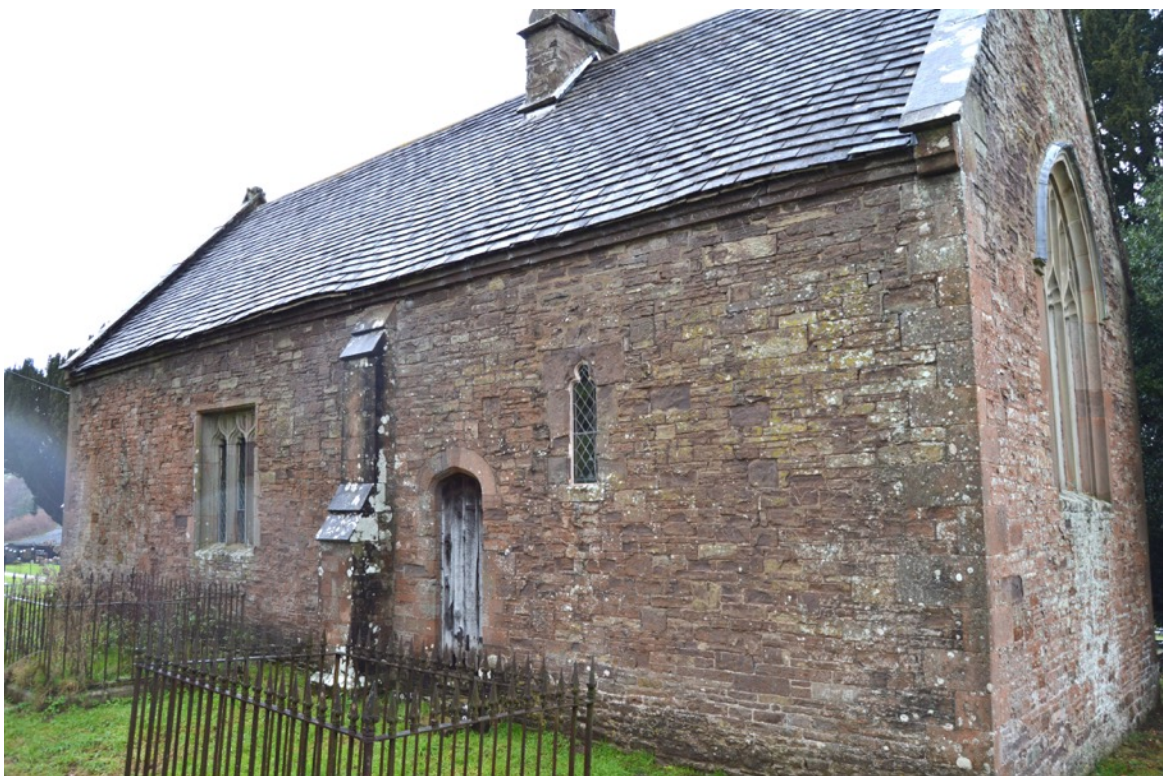
(10.) South side of Nave/Chancel showing delaminating stone work, poor quality roof, and rotting door.

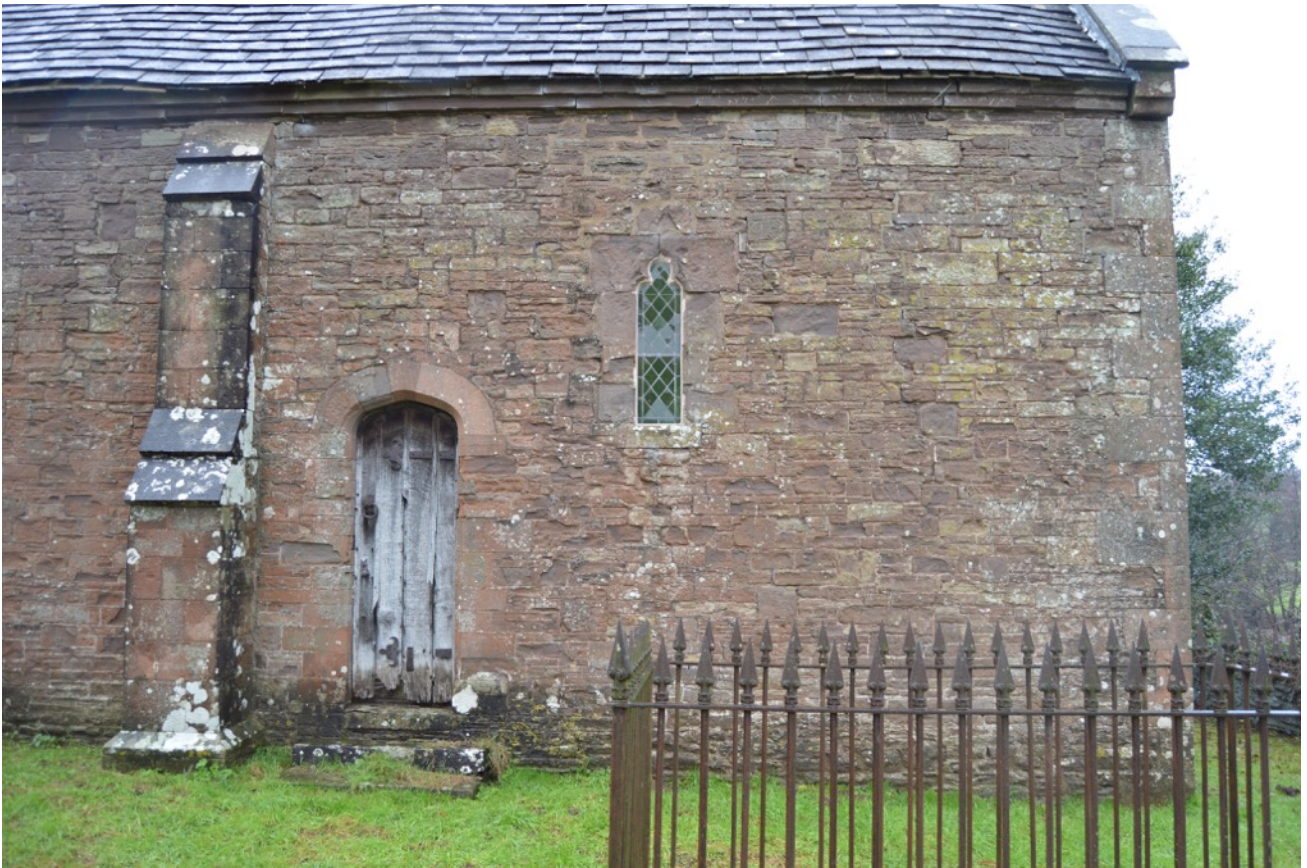
- 7.2. On the north side there are two raised areas of tile at the eaves in an undulating formation. This is rather unusual and it is difficult to say what has caused it. It may have been some misalignment in the structure which has now been covered up with the new tiles without any attempt to straighten out the structure. It was mentioned in the previous inspection, so is not new. A high level inspection and uncovering the tiles will be necessary to determine the exact cause of this defect.

(11.) Undulating formation of roof which is likely to be caused by structural movement in the roof structure.

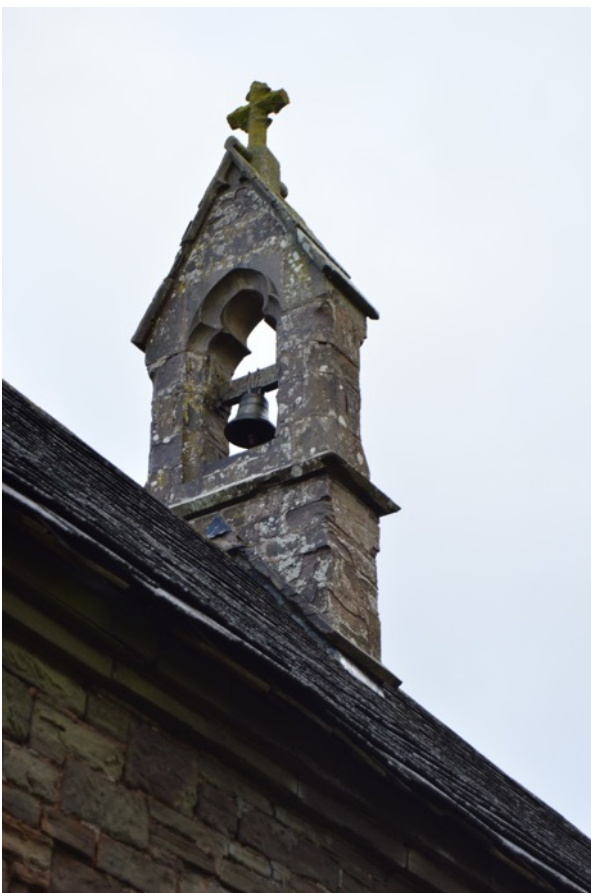
The small belcote located above the Chancel arch was inspected through binoculars. The stonework has eroded with much delamination caused by the wrong bedding of the stones and cement pointing. The apex cross appears to be in reasonable condition.

(12.) General view of Bellcote over Chancel arch.

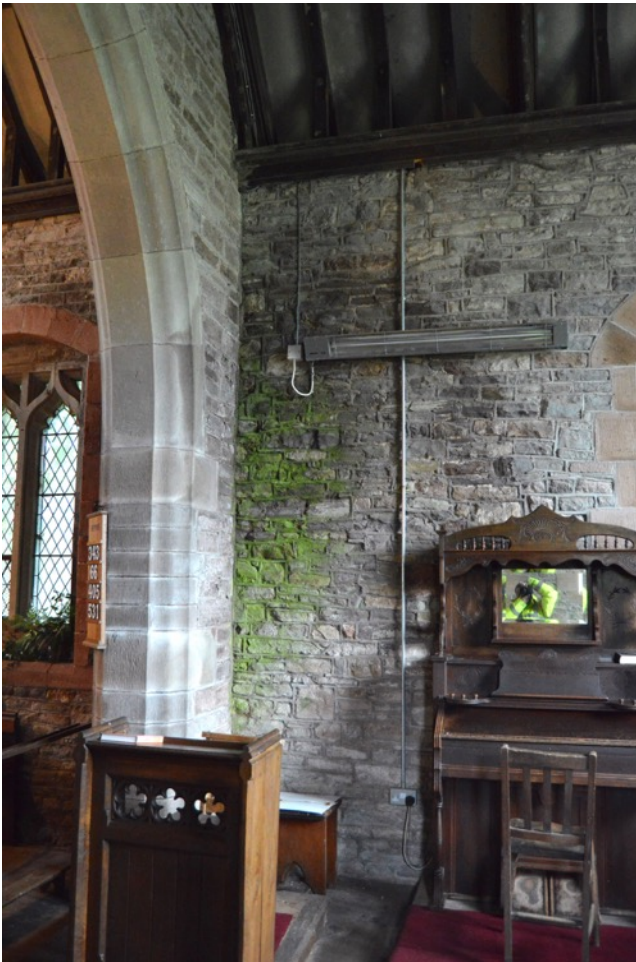
- 11.4. On the north wall of the Chancel where it abuts the Chancel arch, there is a large damp patch with a green mossy surface. Clearly this has been letting in water for some considerable time, and has created a damp environment. There are electrical cables and a socket fixed to the damp wall which is clearly dangerous. It is recommended that this be terminated immediately by a suitably qualified electrician.

(13.) Internal evidence of water ingress resulting in moss growing on the surface of the wall. Electric cables and fittings can be effected by the presence of moisture. This is dangerous. Electric supply should be isolated from this area.

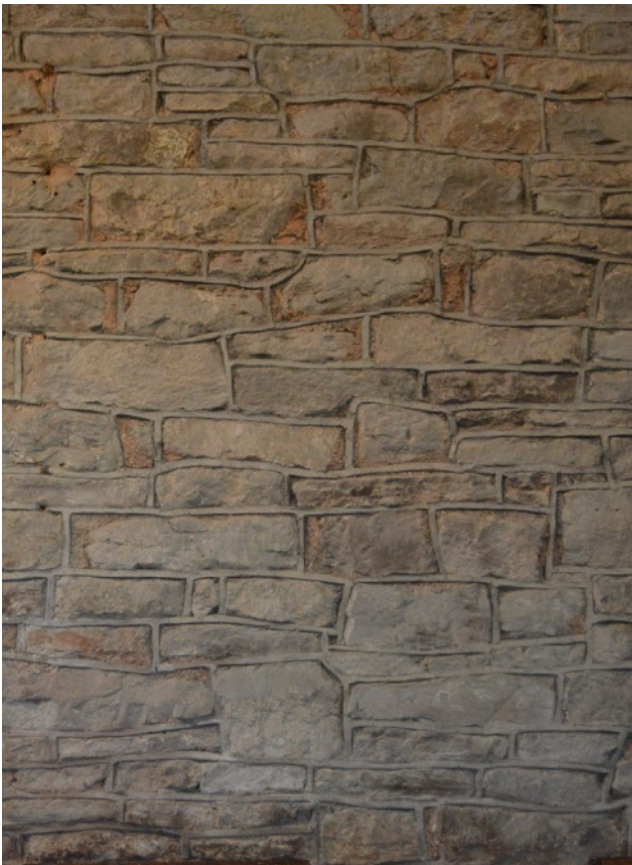
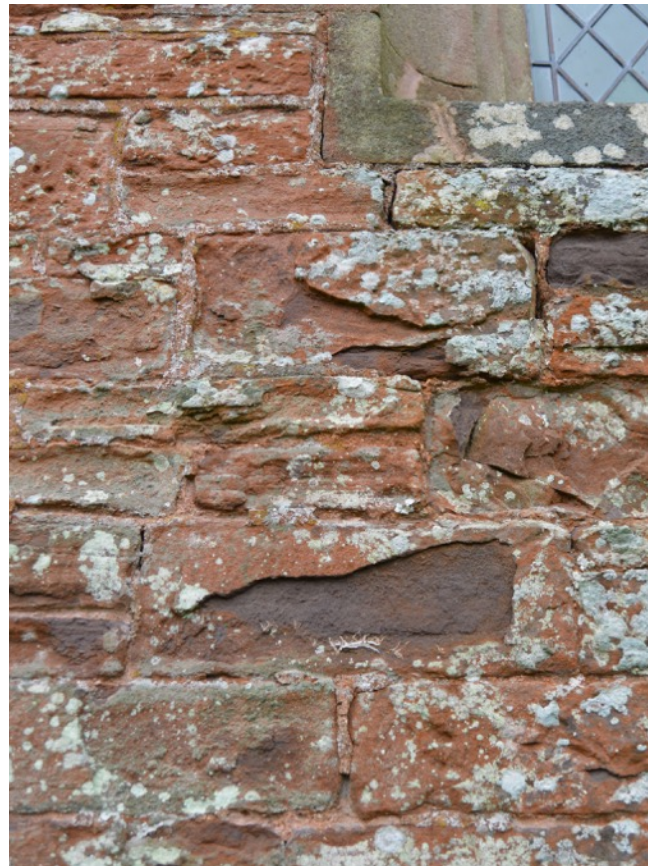
(14.) Large areas of cement ribbon pointing (internal) and delamination of stone (external).

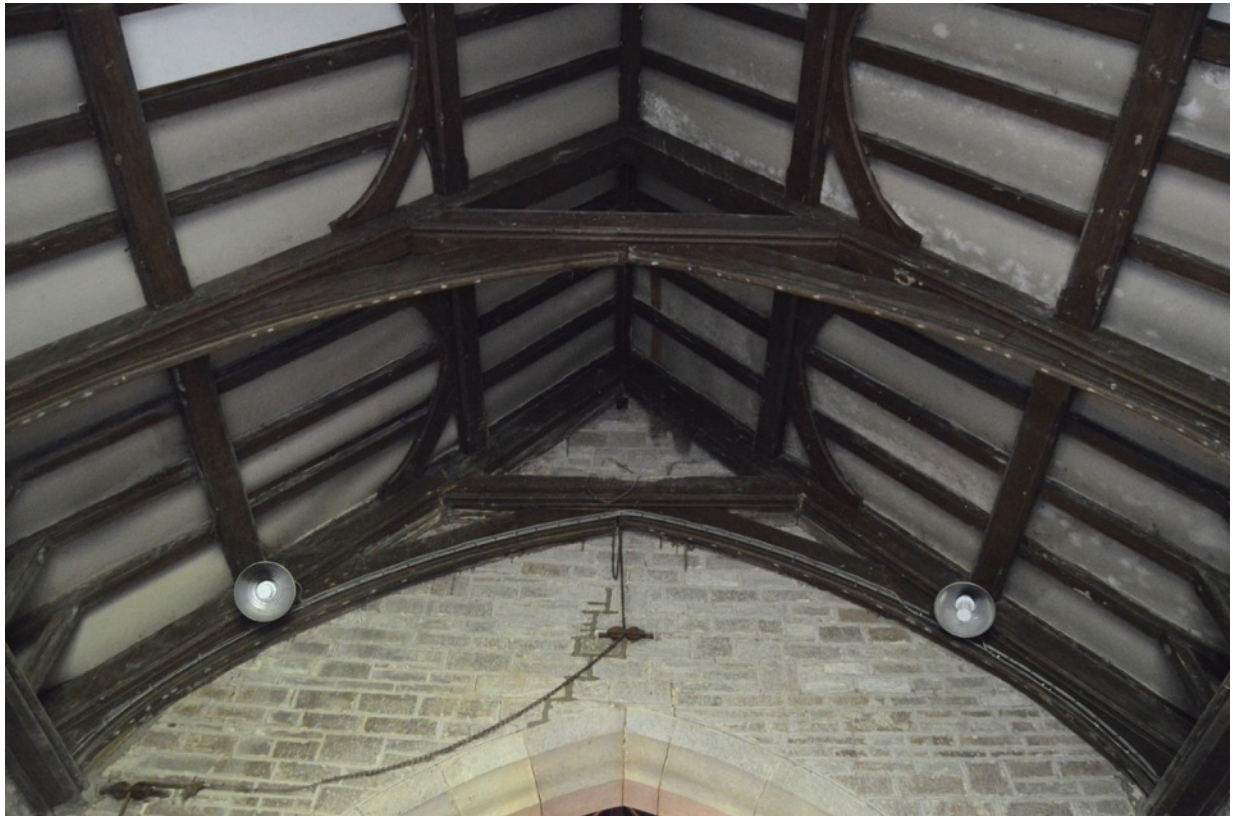
- 11.3. The roof/ceiling above the Chancel appears to be plasterboard between rafters. The boards appear to be sagging and have turned grey and patchy. The rafters and trusses appear to be affected by the damp environment showing slight patched of surface mould. This may be caused by the condensation from the damp environment below, and /or water penetrating the roof coverings above.

(15.) Roof over the Chancel. Note the sagging boards between the rafters with grey mottled effect, suggesting dampness above and/or a damp internal environment.

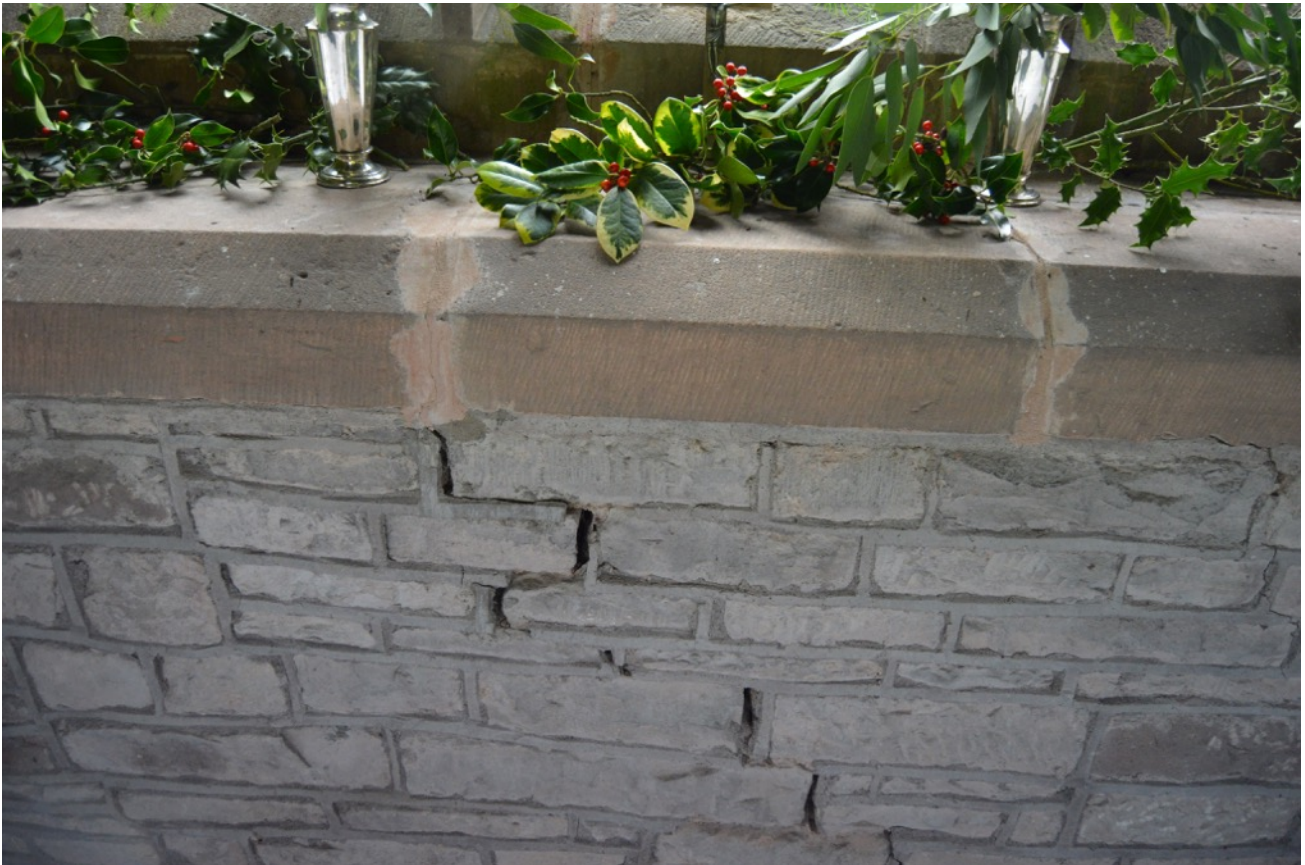
(17.) Internal cracking of the East window in the Chancel caused by structural movement. This needs to be inspected by a structural engineer.

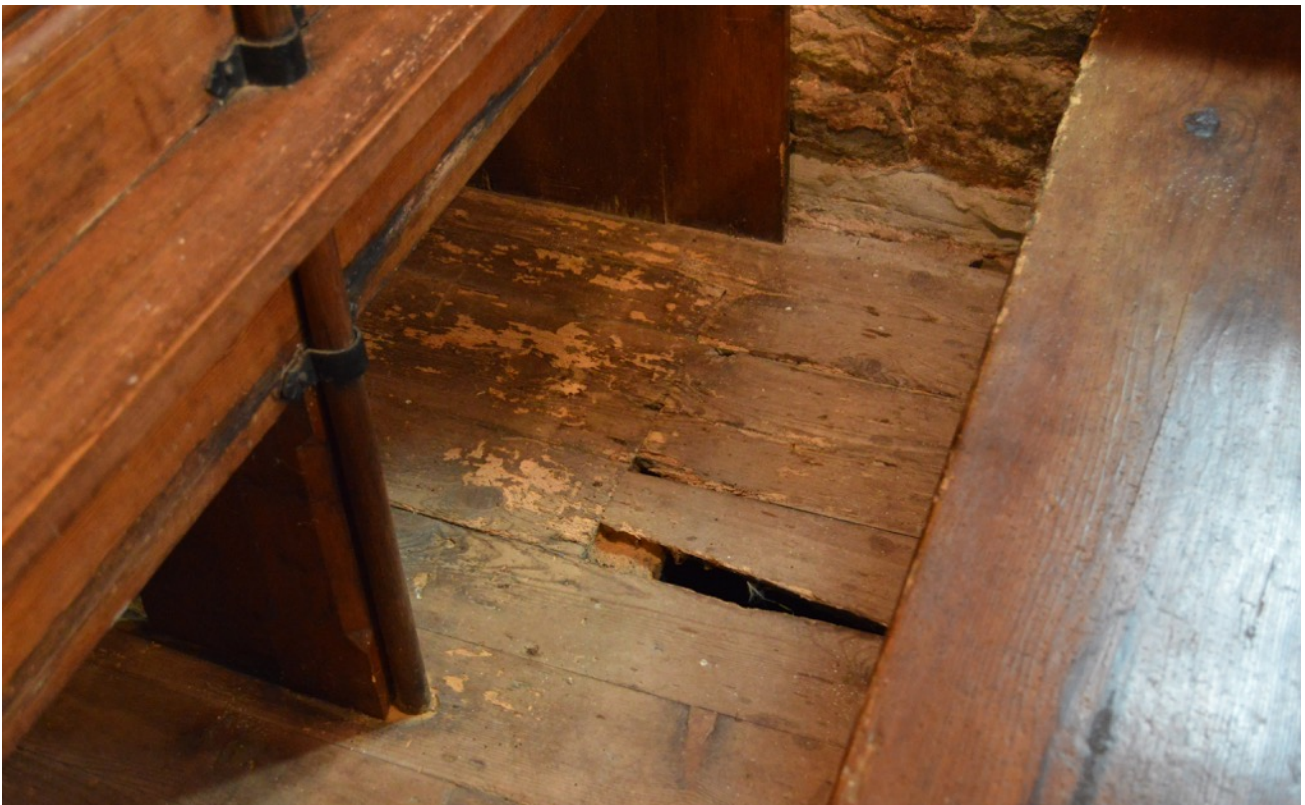
- 11.6. The timber floor beneath the Nave pews (south) are rotting. Some broads are now breaking up and the joists are visible below. there was also signs of rot visible in the floor joists. The pews will need to be taken up as will the floor and new timber joists inserted.

(18.) Internal damage to the timber flooring under the pews. Timber floor joists are also rotten. This area should be closed off as the floor may collapse.
